**Flood Control Project Maintenance
Levee Inspections**
LMA District Cover Sheet
Spring 2017 Levee Inspection Results

Reclamation District No. 0070 Meridian

Spring 2017 Levee Inspection Results

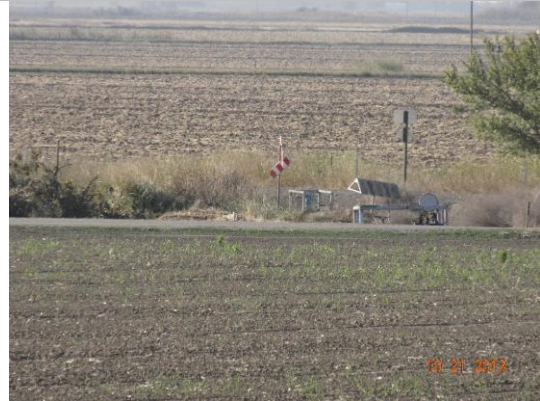
Photo 3 of 3 : UCIP_SP_2017_23463_40620.jpg

Comment Code					
Inspector Comment					
FS_ID:23463 DS_ID:21347 EP_NO: 3804 Repair Type: Non-Urgent Crossing Status: Indicator Found UCIP Comments: Unable to confirm if the indicators that were found in the field correspond to this crossing. Will need to contact PG&E to confirm location of crossing. Photos will need to be updated if the photos attach do not correspond to this crossing. This crossing is referenced in the USACE Periodic Inspection as item USACE_CESPK_MRD1_2012_p_0304 for 12 inch gas pipe. Coordinates between DWR UCIP and USACE PI are approximately 630 feet apart. FIELD_STRUCT_DESC: 12-inch steel gas pipe through the levee, 3.6 feet below the crown. Concrete cutoff wall around pipe at center of levee. Marker sign on waterward shoulder. Rock revetment on waterward slope. (Permit No. 3804-1961) FS Date: 10/21/2013

View of gas line markers approximately 900 feet away.

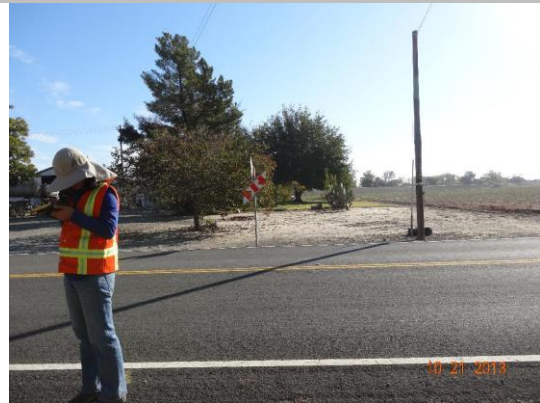
Photo 1 of 3 : UCIP_SP_2017_23384_40249.jpg

LM Start	0.55	Rating **	M	Issue No.	39
LM End	0.55	Issue Type +	En	Location *	WS
Category	Supplemental			GPS Latitude/Longitude	
				Start	End
Item	DWR UCIP Field Study			39.142565 °	39.142565 °
				-121.841600 °	-121.841600 °
DWR ID					
Comment Code					
Inspector Comment					
FS_ID:23384 DS_ID:21415 EP_NO: 15936 Repair Type: Non-Urgent Crossing Status: Indicator Found UCIP Comments: No markers visible on levee slope or levee toe to indicate line crosses levee. Need to contact PG&E to confirm location through levee. Also need to confirm the emergency contact person for this crossing. FIELD_STRUCT_DESC: 8-inch steel pipe through the levee, 2.5 feet below the crown. Gas line markers on the landward side. (Permit No. 15936-2005) FS Date: 10/21/2013

View of markers on the east side of S. Tarke Road.

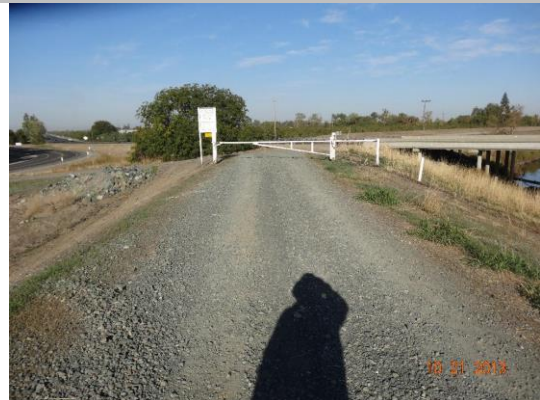
Photo 2 of 3 : UCIP_SP_2017_23503_40780.jpg

Comment Code					
Inspector Comment					
FS_ID:23503 DS_ID:21351 EP_NO: 3686 Repair Type: Non-Urgent Crossing Status: Found UCIP Comments: Dense vegetation limits the inspector's visibility to identify signs of pipe failure (leaks) along the waterward slope. Recommend removing vegetation along pipe alignment to conduct proper inspection of structure and appurtenances. Unable to find the gate valve on landward side. Walkway on waterward side in bad shape. This crossing is referenced in the USACE Periodic Inspection as item USACE_CESPK_MRD1_2012_p_0300 for 18 inch pipe. Pipe on LS is 10 inch not 18 inch. SEE UCIP DS_ID 21350 for details pertaining to 18 inch pipe. FIELD_STRUCT_DESC: 10-inch pipe and electrical conduit through the levee, 14.8 and 1.0 feet below the crown, respectively. Gate valve on landward end--not found during 10/21/13 pipe inventory. Pump on pile structure in stream. Walkway to slide gate on waterward end. Rock revetment on waterward slope. Pump and concrete support piers at waterward toe installed under Permit No. 3686 (1963). Service pole with meter and control panel at landward toe. FS Date: 10/21/2013

View of levee crown looking downstream.

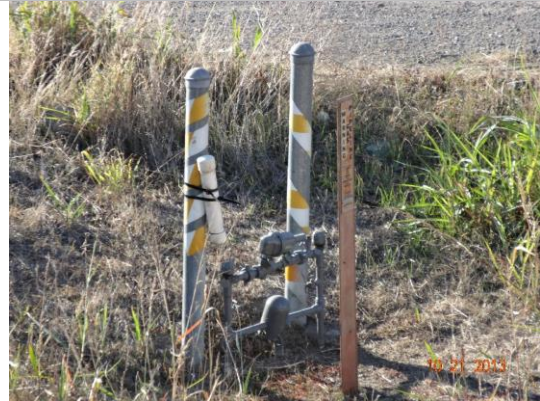
Photo 3 of 3 : UCIP_SP_2017_23467_40640.jpg

Comment Code					
Inspector Comment					
FS_ID:23467 DS_ID:21354 EP_NO: 14802 Repair Type: Non-Urgent Crossing Status: Indicator Found UCIP Comments: Need to contact owner to determine status of crossing. Need date of last inspection and confirmation that crossing is still in operable condition. Markers found about 159 feet upstream of coordinates at the crossing of the ramp and S. Tarke Road (39.142684, -121.842685). FIELD_STRUCT_DESC: 4-inch steel gas pipe through the levee, 2.5 feet below the crown. Aluminum pipe marker on landward slope. (Permit No. 14802-1987) Contact emergency information for Pacific Gas & Electric Company 1-800-344-4749? 4742? or 1-916-742-3251. FS Date: 10/21/2013

Close-up of the additional appurtenances for gas line located landward side.

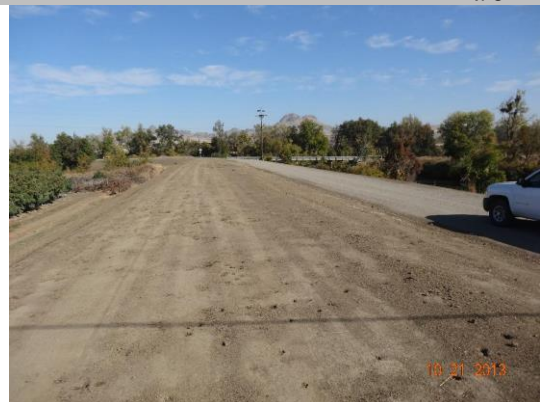
Photo 1 of 3 : UCIP_SP_2017_23526_40942.jpg

Comment Code					
Inspector Comment					
FS_ID:23526					
DS_ID:21355					
EP_NO: 9961					
Repair Type: Non-Urgent					
Crossing Status: Found					
UCIP Comments: Dense burrow activity present on both waterward side and landward side. Recommend addressing burrow activity at this location. Also recommend having owner clear vegetation blocking access along walkway. This crossing is referenced in the USACE Periodic Inspection as item USACE_CESPK_MRD1_2012_p_290.					
FIELD_STRUCT_DESC: 10-inch (not 12-inch as noted in desk study) steel pipe through the levee, 5.4 feet below the crown. Siphon breaker in CM pipe riser on landward slope. 24-inch concrete standpipe at landward toe. Walkway to pump on pile structure in stream. This pipe was retained under ABO No. 9961 (1974).					
FS Date: 10/21/2013

View of levee crown and waterward berm looking downstream from crossing.

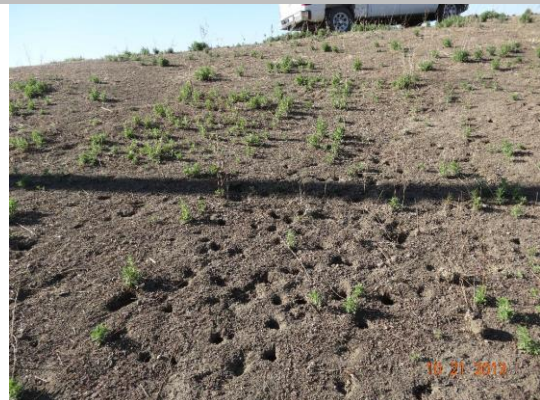
Photo 2 of 3 : UCIP_SP_2017_23508_40819.jpg

FS_ID:23508
DS_ID:21336
EP_NO: N/A
Repair Type: Non-Urgent
Crossing Status: Found
UCIP Comments: Need to find owner to determine if crossing is still in use. If crossing is no longer in use owner will need to coordinate with DWR inspector and CVFPB to remove according to Title 23 requirements. Evidence of high burrow activity on waterward side recommend addressing issue. This crossing is referenced as USACE_CESPK_MRD1_2012_p_0230 in the USACE's PI report for no USACE recommendation letter available -- correction pipe is 12-inch not 16-inch.
FIELD_STRUCT_DESC: 12-inch pipe through the levee, 4.0 feet below the crown. Siphon breaker on the landward slope. Concrete distribution box (7 ft by 9 ft) at landward toe. Service pole on waterward slope. Pump on concrete sump on waterward slope. Overhead power line crosses levee at location. This pipe was retained under ABO No. 9948 (1974) issued to Edward E. and Doris M. Nall. Permit No. 613 issued in May 29, 1934 is for 12 inch pipe issued to Waldo Nall.

Dense burrow activity found on waterward slope.

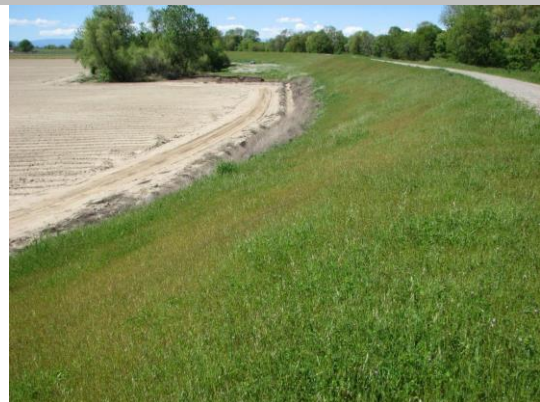
Photo 1 of 1 : SP_2017_RD0070_29_27_20170315_00003.jpg

LM Start	2.74	Rating **	M	Issue No.	27
LM End	2.82	Issue Type +	En	Location *	LS
Category	Earthen Levee			GPS Latitude/Longitude	
				Start	End
Item	Encroachments			39.157741 °	39.158135 °
				-121.871588 °	-121.872979 °
DWR ID	DWR_RD0070_01_s_2016_27				
Comment Code					
DT : Ditch					
Inspector Comment

Concrete ditch at landside toe.

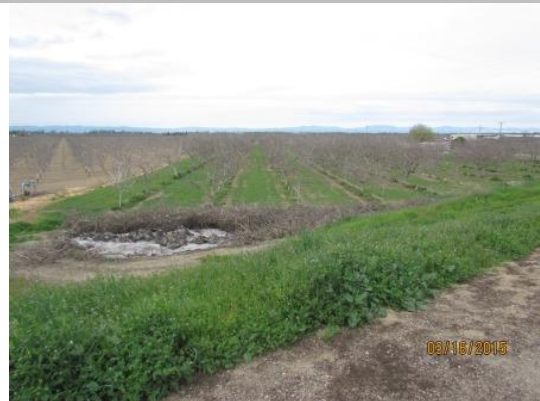
Photo 1 of 1 : SP_2017_RD0070_29_34_20170315_00009.jpg

LM Start	4.57	Rating **	M	Issue No.	34
LM End	4.57	Issue Type +	Ma	Location *	LS
Category	Earthen Levee			GPS Latitude/Longitude	
				Start	End
Item	Encroachments			39.167168 °	39.167168 °
				-121.899102 °	-121.899102 °
DWR ID	DWR_RD0070_01_s_2015_34				
Comment Code					
PR : Prunings					
Inspector Comment					
Remove the prunings from landside toe.

View of the prunings along the landside toe.

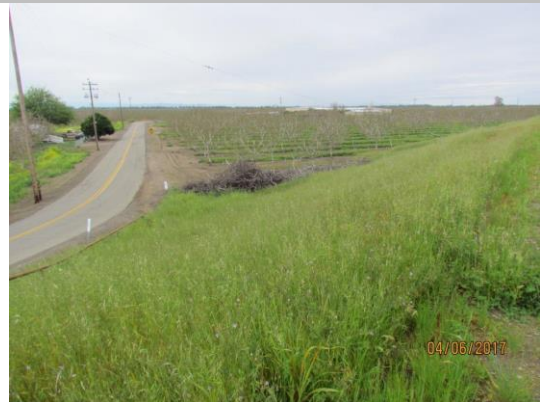
Photo 1 of 1 : SP_2017_RD0070_29_35_20170410_00064.jpg

LM Start	4.64	Rating **	M	Issue No.	35
LM End	4.64	Issue Type +	En	Location *	LS
Category	Earthen Levee			GPS Latitude/Longitude	
				Start	End
Item	Encroachments			39.168030 °	39.168030 °
				-121.899805 °	-121.899805 °
DWR ID	DWR_RD0070_01_s_2017_35				
Comment Code					
PR : Prunings					
Inspector Comment					
Remove the prunings from the landside toe.

View of the prunings along landside toe.

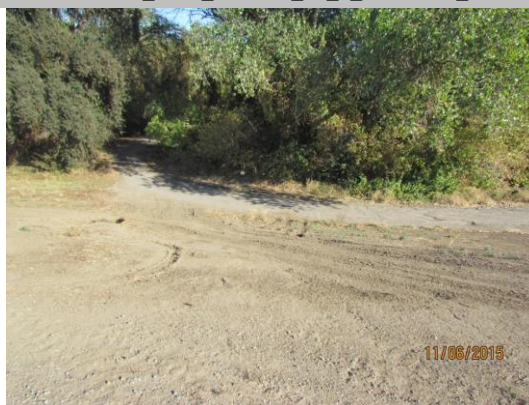
Photo 2 of 2 : SP_2017_RD0070_29_6_20170315_00002.jpg

View of the vehicle erosion along the waterside slope.

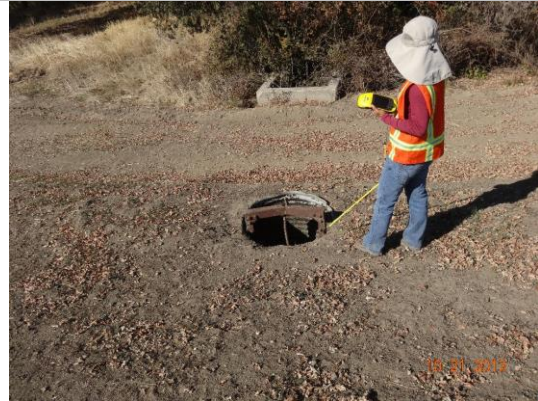
Photo 2 of 3 : UCIP_SP_2017_23529_40963.jpg

CMP riser with screw gate inside. Gate is missing the handle to close gate.

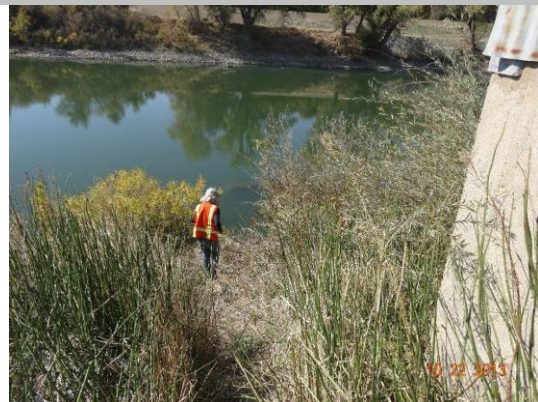
Photo 3 of 3 : UCIP_SP_2017_23891_41837.jpg

Dense vegetation covers pipe intake on waterward side.

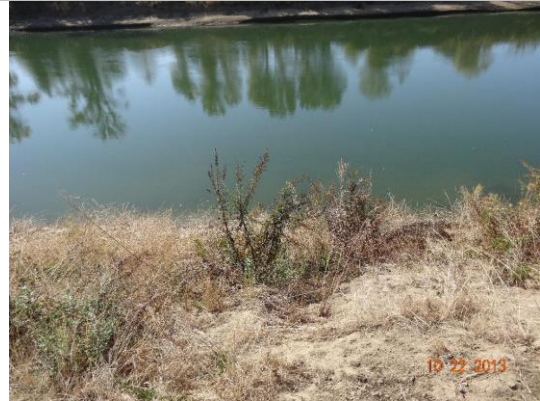
Photo 3 of 3 : UCIP_SP_2017_23892_41840.jpg

Dense vegetation on the waterward edge.

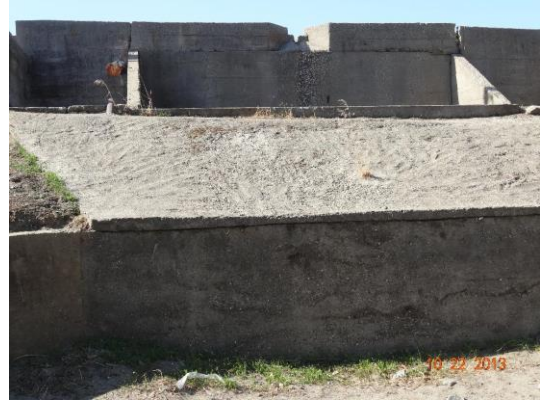
Photo 1 of 1 : UCIP_SP_2017_23961_42098.jpg

Concrete headwall located on landward side--no pipe. Only visible pipe is the pipe located at the far left (downstream end).

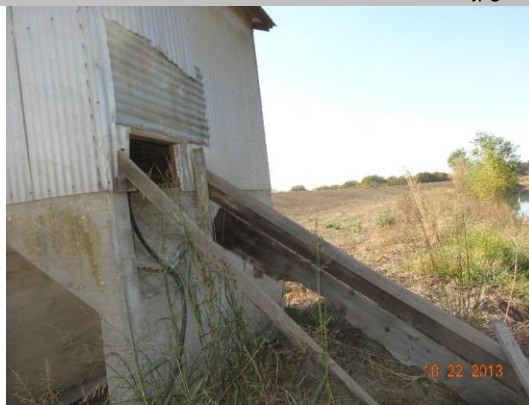
Photo 2 of 3 : UCIP_SP_2017_23964_42116.jpg

No pipe exists the pump house on waterward side.

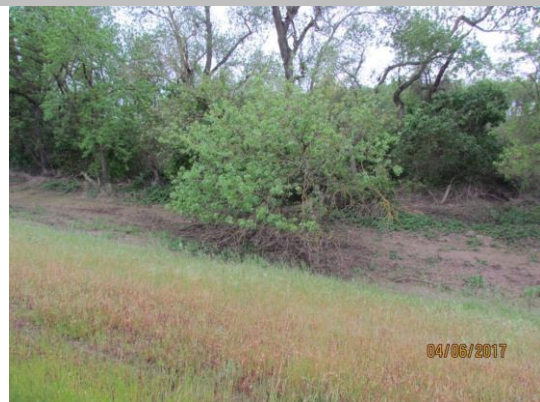
Photo 1 of 1 : SP_2017_RD0070_30_67_20170410_00119.jpg

View of the tree along the waterside. Toe.

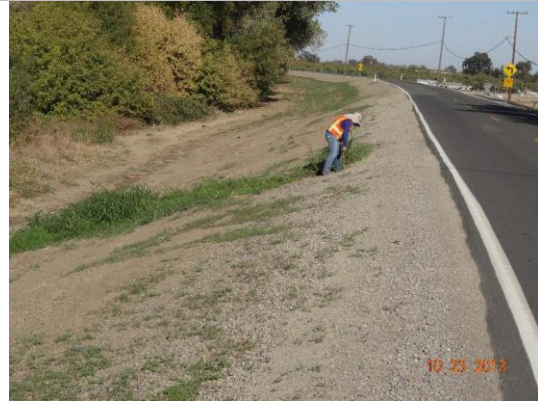
Photo 1 of 3 : UCIP_SP_2017_50007_42684.jpg

Vegetation on WS where leak found.

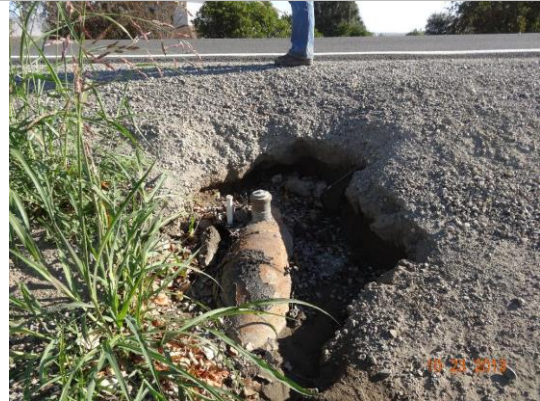
Photo 2 of 3 : UCIP_SP_2017_50007_42680.jpg

Damage to WS shoulder due to leaky pipe or siphon breaker.

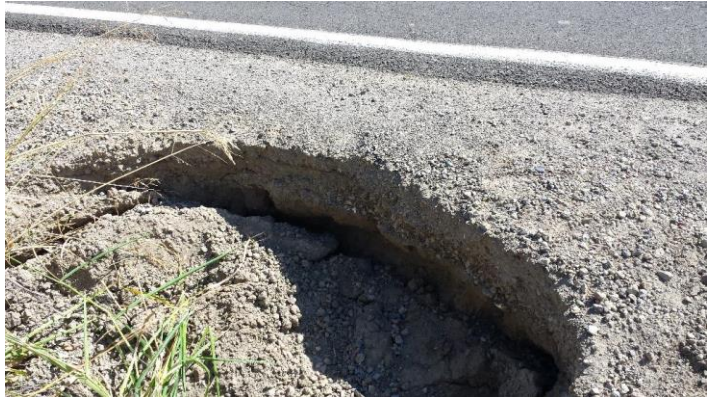
Photo 3 of 3 : UCIP_SP_2017_50007_74614.jpg

Slope damage within 2 feet of County Road.

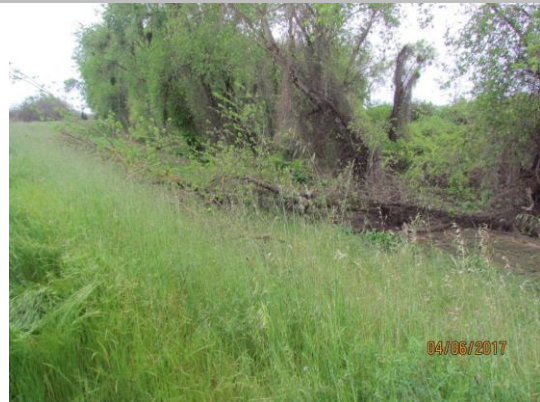
Photo 1 of 1 : SP_2017_RD0070_30_68_20170410_00120.jpg

View of the tree along the waterside slope and toe.

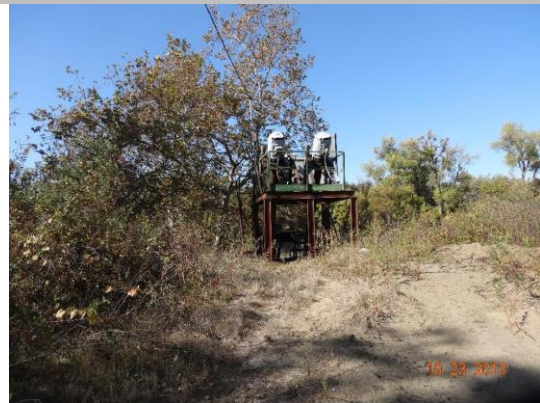
Photo 2 of 3 : UCIP_SP_2017_24196_42692.jpg

Pump station on waterward side dense vegetation on slope.

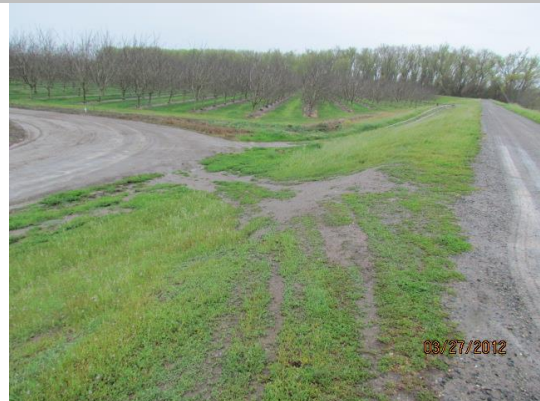
Photo 1 of 1 : SP_2017_RD0070_30_6_20170315_00003.jpg

View of vehicle erosion along landside slope.

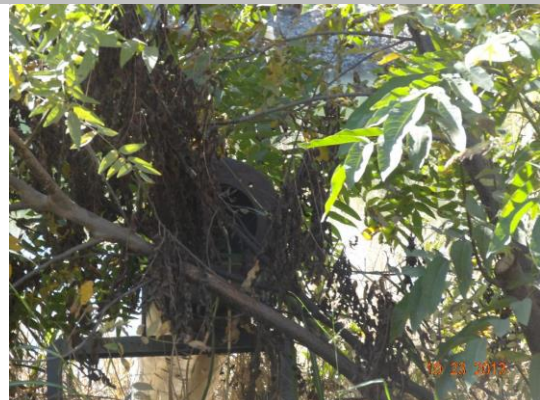
Photo 3 of 3 : UCIP_SP_2017_47033_42143.jpg

Pipe section exposed unable to determine if it is still in use.

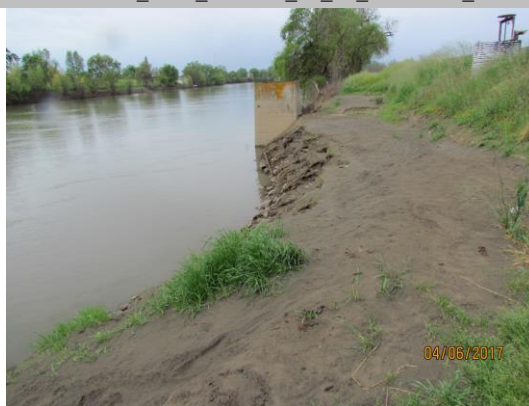
Photo 1 of 1 : SP_2017_RD0070_30_72_20170410_00122.jpg

View of the erosion along the waterside slope.
